Exhibit C Inspection Report, December 13, 2021, 204 Highland Rd.

# **INSPECTION REPORT**

Prepared for: Edwin Alexander December 13, 2021

204 Highland Road Statesboro, GA

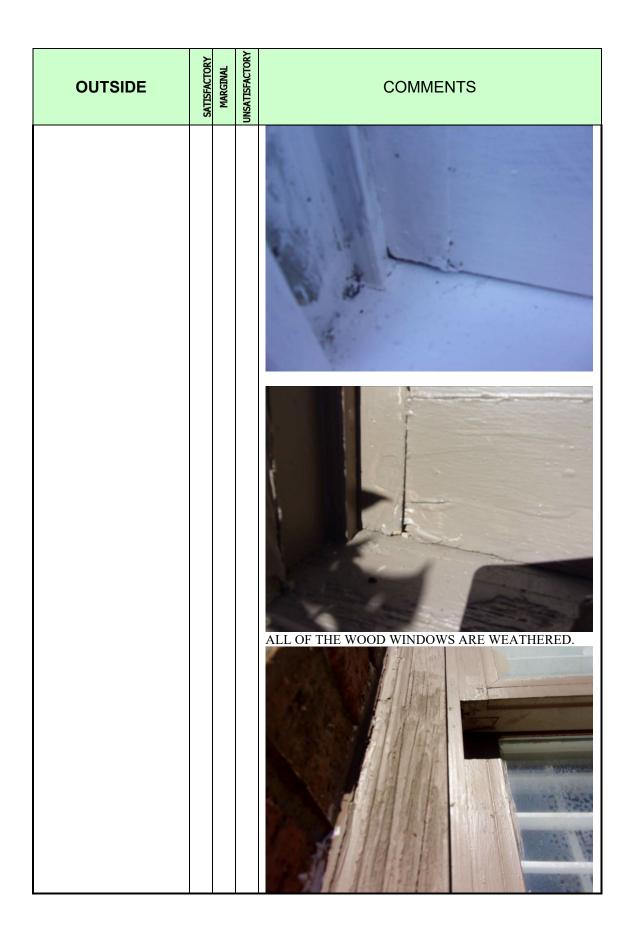
OUTSIDE	SATISFACTORY	MARGINAL	UNSATISFACTORY	COMMENTS
Screens/Shutters		X		THERE IS LOOSE SCREEN AROUND THE SCREENED PORCH.
Receptacles			X	THE RECEPTACLES ARE NOT GROUND FAULT PROTECTED.
Exterior Doors	X			THE WOOD DOORS ARE WEATHERED.
Windows			X	THERE IS WATER DAMAGE TO SEVERAL OF THE WOOD WINDOWS AOUND THE HOUSE.

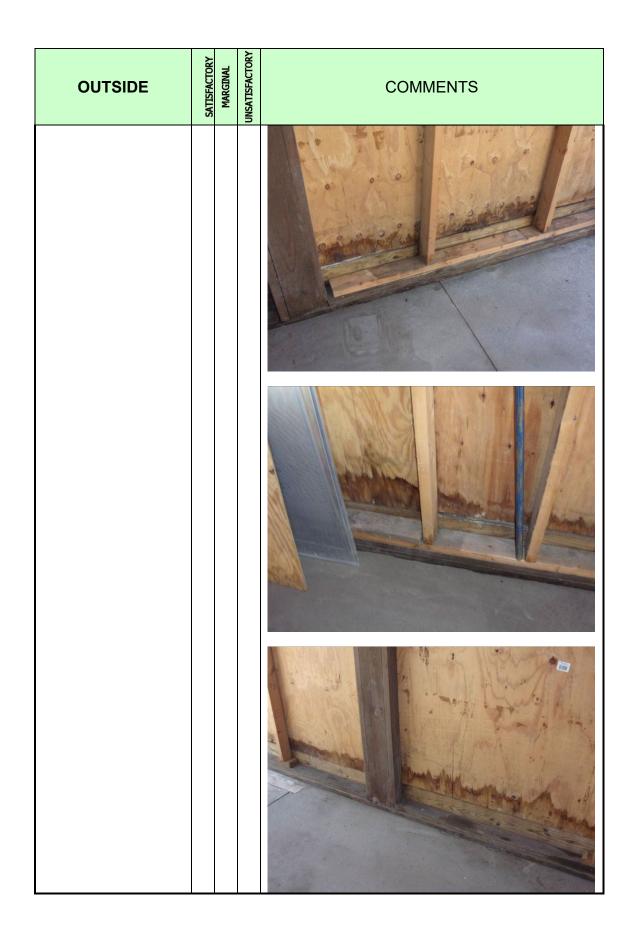
OUTSIDE	SATISFACTORY	MARGINAL	UNSATISFACTORY	COMMENTS
				THERE IS WATER DAMAGE TO THE SIDING AROUND THE GARGAE.  THE WOOD SIDING IS WEATHERED. THERE IS WATER INTRUSION AND DAMAGE ON THE INTERIOR SIDE OF THE GARAGE WALLS.

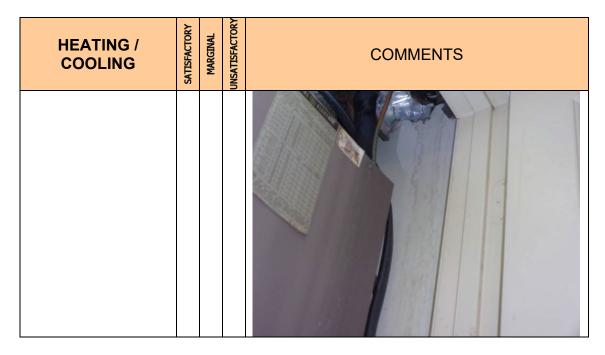
<b>-</b>	
HEATING / COOLING	SATISFACTORY	MARGINAL	JINSATISFACTORY	COMMENTS
Operation	X			I COULD NOT TEST THE AIR CONDITIONING BECAUSE THE TEMEPRATURE HAS BEEN BELOW 55 DEGREES IN THE PAST 24 HOURS. THE ARE G.E. SYSTEM IS OLDER AND AT THE END OF ITS LIFE EXPECTANCY.
Filters	X			
Returns	X			
Vents/Registers	X			
Duct Work	X			THERE IS DUCT WORK THAT CANNOT BE ACCESSED.
Other		X		THERE ARE WATER STAINS IN THE MECHANICAL CLOSET.
